# BLASTING WORKS FOR CLEARING OF STREAM BED KNĚŽMOSTKA BROOK

On the base of request of the Labe Water Authority, state owned enterprise, was executed a prefeasibility study for performance of blasting works for a clearing of clogged stream bed of the Kněžmostka brook in the protected area Natura 2000-Drhleny. The Water Authority took a step to fruitful execution of the blasting works in the brook after approval of the prefeasibility study. The sludge in the stream bed was released and flowed away from a site where produced a problems with flowing. The seismic methods and resistivity tomography proved successful for realization of the project.

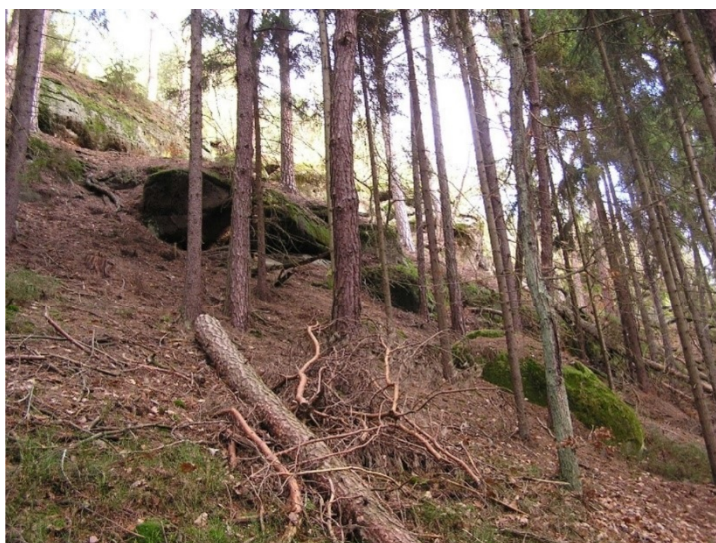
**Fig. 3 Steep slopes with sandstone blocks**

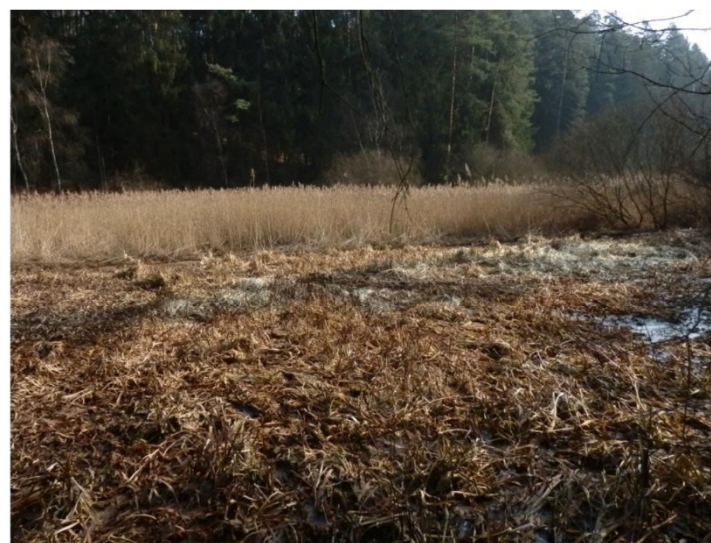
**Fig. 4 Clogged meadows**

Forest paths are very narrow and bad quality. A transport for excavators and the similar machinery is practically impossible. See Fig. 2. The slope round the brook is steep. See Fig. 3. The stream bed was clogged. See Fig. 4. The difficult field conditions were the case of an idea that for a clearing of clogged stream bed will be used blasting works.

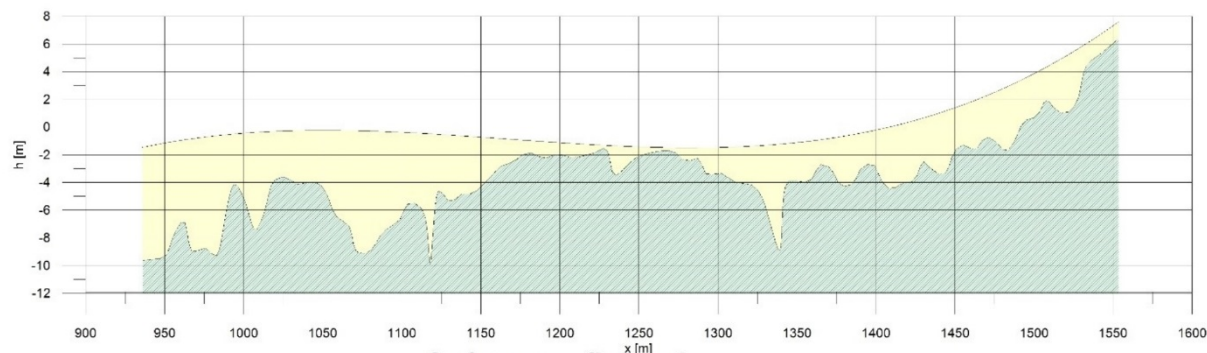
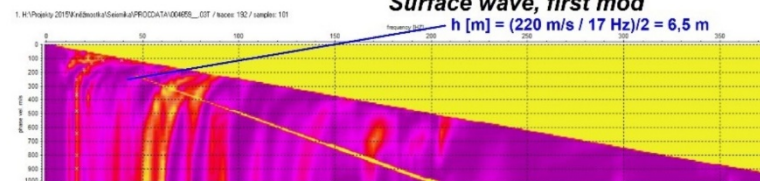
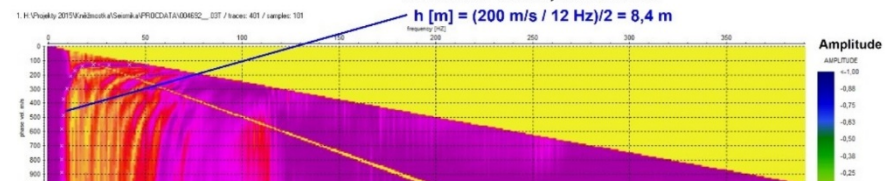
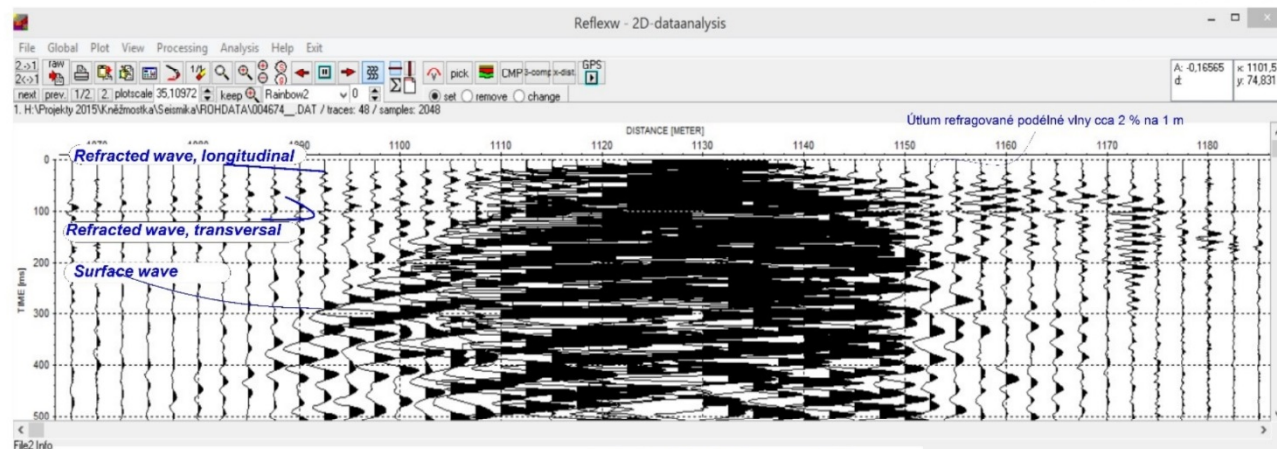
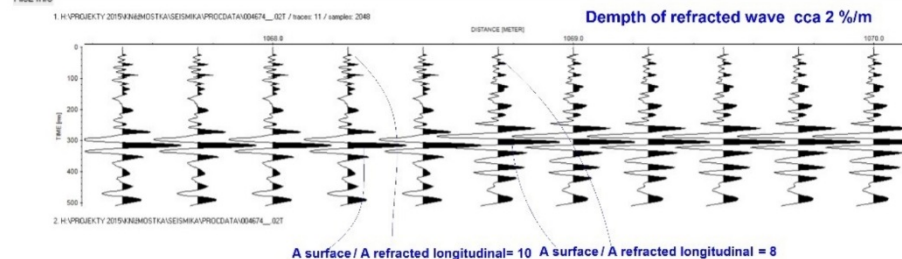
Fig. 5 Complex analysis of seismic waves from profile P1

- Quaternary sediments, eluvium median of velocity 310 m/s
- Bedrock (sandstone), median of velocity 2400 m/s

The interface between the Quaternary sediments and the bedrock is in the depth from 8 to 0 m.

The seismic velocity of the longitudinal wave for superficial sediments is round 310 m/s.

The seismic velocity of the longitudinal wave for the bedrock (sandstones) is round 2400 m/s.

Surface waves have several modes and are very intensive. The typical velocity is 210 m/s. The thickness of the surface layer for these waves are approx. 7 m.

The dominant frequency is 25 Hz. The damping for amplitude of longitudinal waves is circa 2% / m. The intensity of the surface waves are approximately 9 times more than intensity of the longitudinal waves.

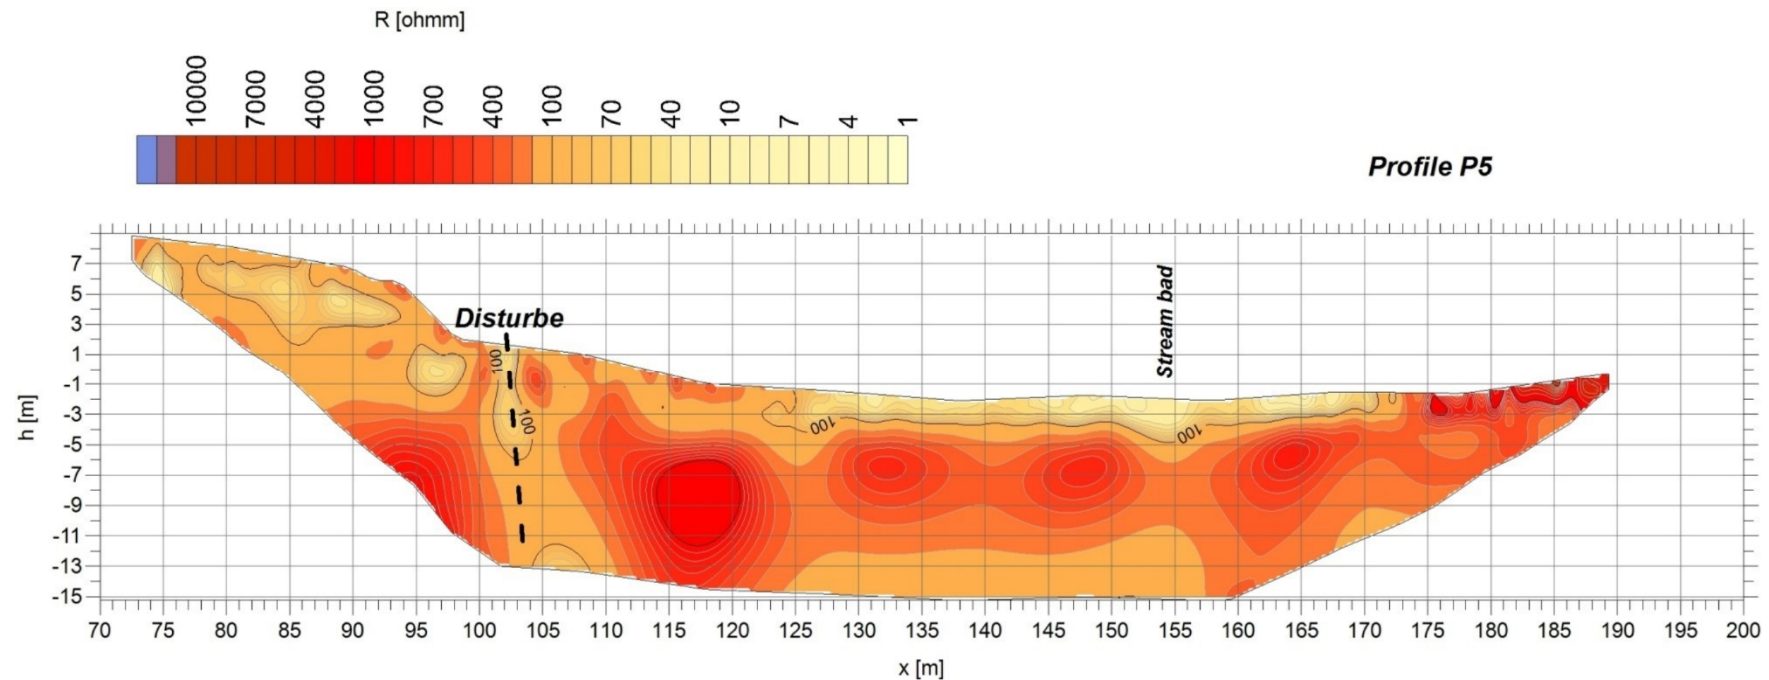
**Fig. 6 Resistivity tomography, Profile P5**

Sandstones (high resistivity) are followed by clays (low resistivity).

The river muds were detected in the vicinity of the brook. The thickness of the sludge in the center of stream bed is round 3 m (maximum).

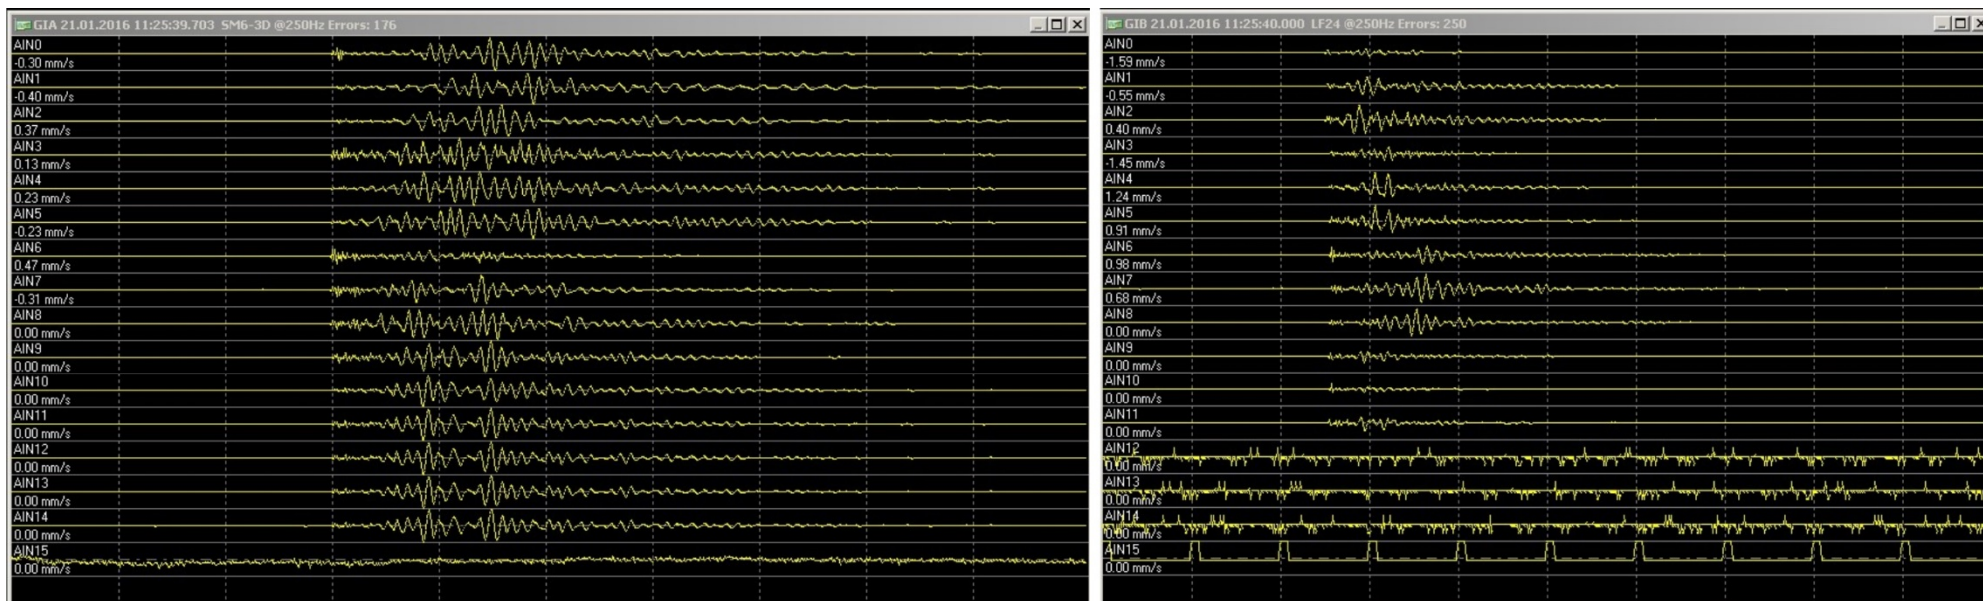
The Terraloc equipment, which worked in the vicinity of the shoot master, detected vibrations of longitudinal waves with velocity from 1.5 to 9.5 mm/s and of transversal velocity between 0.5 to 9.5 mm/s. The tracks for these waves were changed from 15 to 30 m. The shooting was executed at the valley where are not practically buildings and slopes are consist out of compact sandstones or clays. The fixed equipment GIA and GIB had the oscillations mostly round 1 mm/s (maximum for GIA 3.5 mm/s and for GIB 4.6 mm/s. These equipment was far away from shooting mostly 100 – 1000 m. We can state that the buildings and cottages in the Nová Ves village and Drhleny village were safe, but natural oscillation (swing of trees, traffic) was surprisingly intensive. The scrutiny examination prevents for all buildings in the area of interest and we can state, that we had not any accident or damage on the end of our works.

**Fig. 12** Sections of primary seismic records of the equipment GIA(left) and GIB (right). The seismic record (left), part with maximum velocity 0.5 mm/s (5 kg explosive, distance 200 m). The seismic record (left), part with maximum velocity 1.6 mm/s (5 kg explosive, distance 150 m)

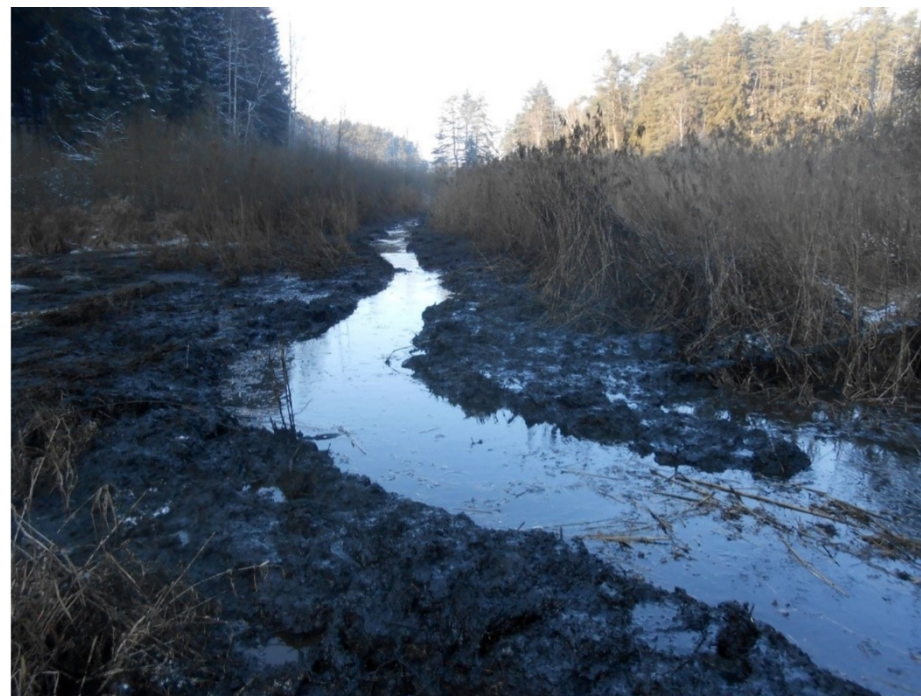
The blasting works were useful and opened flow rate of the clogged stream bed of Kněžmostka brook between Nová Ves village and the small barrage (dam) near Drhleny village. The works were possible on the base good knowledge of geological and geotechnical conditions. This knowledge was down to precise seismic and geoelectrical measurement. The project was started by prefeasibility study and the blasting works were controled by carefully seismic monitoring. The blasting works were underway without any accidents and were more gentle to the nature than earthworks with machinery. The seismic measurement detected standard conditions, but with the warning, that blasting works form very intensive surface wave which run far from narrow valley. The geophysical data was put to a database and are ready alternatively to father detailed study. The Fig. 14 illustrates the open stream of the Kněžmostka brook.

*Fig. 14 The open stream bed of the Kněžmostka brook*
