DISCONTINUOUS DEFORMATIONS AS A RESULT OF HORIZONTAL DEFORMATIONS

NESPOJITÉ DEFORMACE JAKO VÝSLEDEK HORIZONTÁLNÍCH DEFORMACÍ

*Piotr Strzałkowski*¹

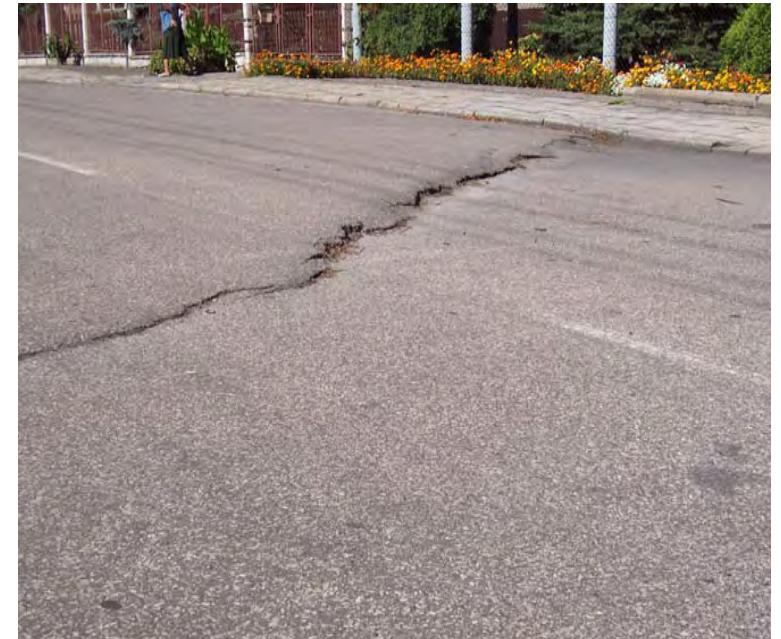
Fig.2 Example of fault occurrence, crosswise the roadway (Strzałkowski, Scigala, 2003)

Particularly often there can be found faults (Fig.2), caused by mining, especially with cave-in of roof to common borderline in several seams (Strzałkowski, Scigala, 2003). Bumps occur relatively rarely, but are equally dangerous to buildings placed on surface, as rock steps. Examples of that kind of deformations, its reasons and its occurrence's impact on surface, were presented in next part of this work.

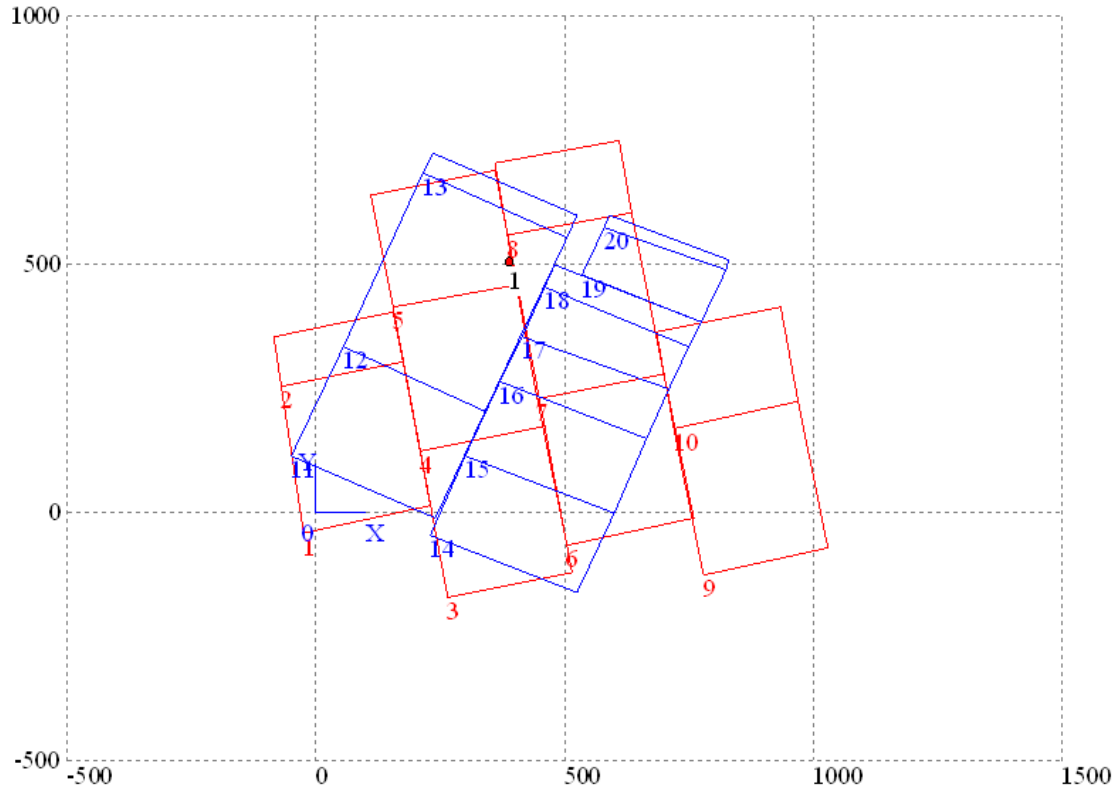
Fig.3 Schematic of particular field's localization in comparison to parcel

exploitation's localization in comparison to parcel and coefficient of roof control, are presented in Tab.1. All exploitation was provided in the wall system with roof-rock caving. Schematic of location of particular fields in comparison to parcel, are presented on Fig. 3.

In calculations, seam's tilt and exploitation edge, weren't took into account. First, the ratios were calculated for the deformation approximately associated with a discontinuous deformation localized in the south of the plot (Fig.3). Subsidence of point and maximal deformations were calculated by simulating walls movement for 5-day intervals.

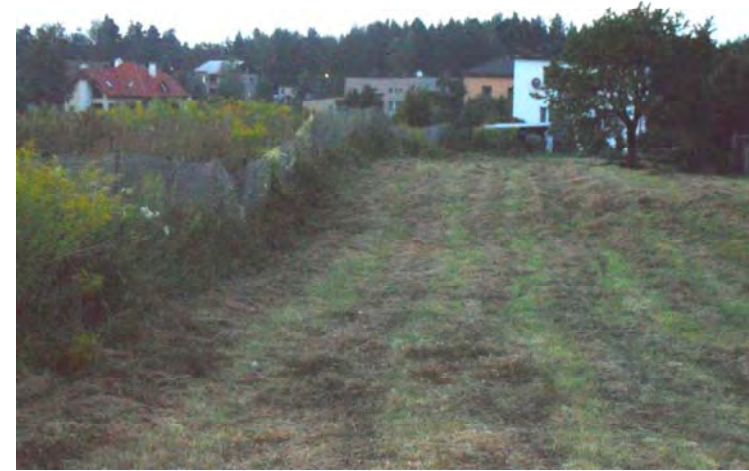
Fig.4 General deformation's sight

In building's area discontinuous non-linear deformations in bump's form were pronounced. Those deformations caused damage of newly erected residential building. Currently demolition area is overgrown with weeds, so deformation is noticeable rather on neighboring property (Fig.2).

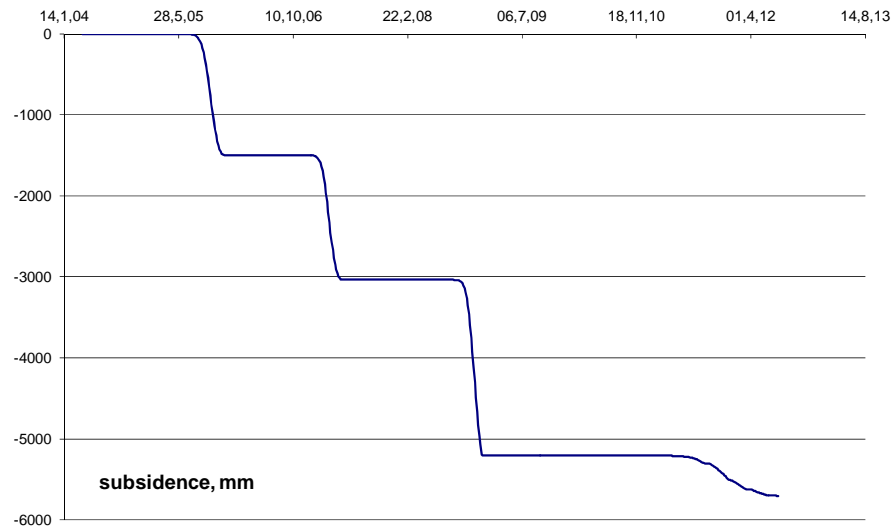
Fig.5 *Calculated subsidence of point over time- graph*

Immediate disclosure of the exploitation's impact was assumed. Subsidence graph is shown in Figure 5, and the maximum horizontal deformations are shown in Figure 6.

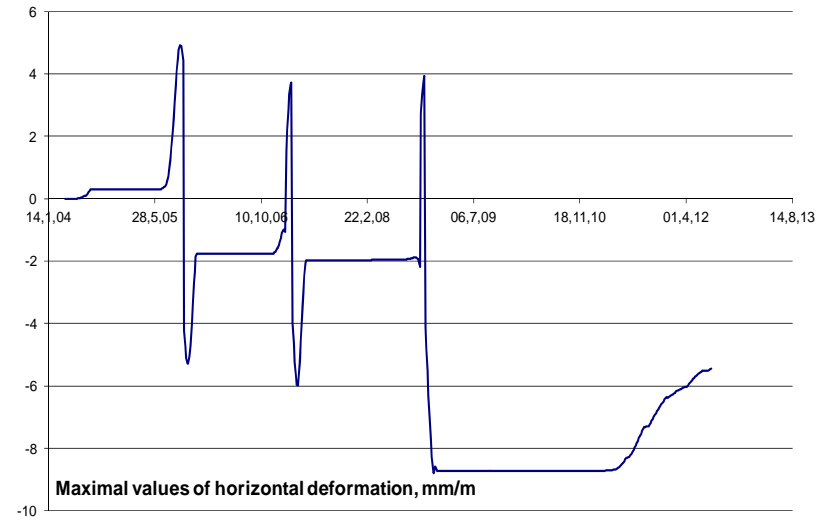
Fig.6 *Maximal calculated horizontal deformation of point over time- graph*

continuation of exploitation, deformation levels declined to approximately -5.5 mm/m, however those were still compressive deformations. As mentioned above, immediate disclosure of the exploitation's impact was assumed. If so-called time factor (the coefficient describing delay in revealing the influence) were taken into account, the extreme values E_{\max} would have occurred somewhat later – in consecutive months of 2009.

As can be seen from Figure 6, at the time of exploitation the area was undergoing horizontal tensile deformation (positive) and compressive (negative) alternately. In early 2009, there were horizontal compressive deformations of the greatest values E_{\max} of approximately -8.7 mm/m. As a result of the
