SUCSESSES AND PITFALLS OF GEOPHYSICAL SURVEY FOR VERIFYING THE PRESENCE OF UNDERGROUND STRUCTURES IN THE AREA OF FORMER FOUNDRIES (CASE STUDY)

Abstract

The environment in which a geophysical survey is conducted is one of the determining factors in the choice of proper applied methods. This study presents the results of a comprehensive geophysical survey aimed at verifying the presence of remnants of underground structures, foundations, and tanks across the former foundries in Krnov (Czech Republic). The site constitutes an extensive area in which, as the survey progressed, it became clear that the near-surface layer contained a large quantity of heterogeneous metallic material from the former foundry. Magnetic field measurements, selected for the initial areal mapping, together with supporting ground-penetrating radar (GPR) measurements, were therefore supplemented by dipole electromagnetic profiling (DEMP) due to the strong interference. Despite pronounced noise and a large number of shallow anomalies, by appropriate processing and display of the individual datasets we were ultimately able to build a coherent picture of the spatial distribution of anomalous responses of the meas

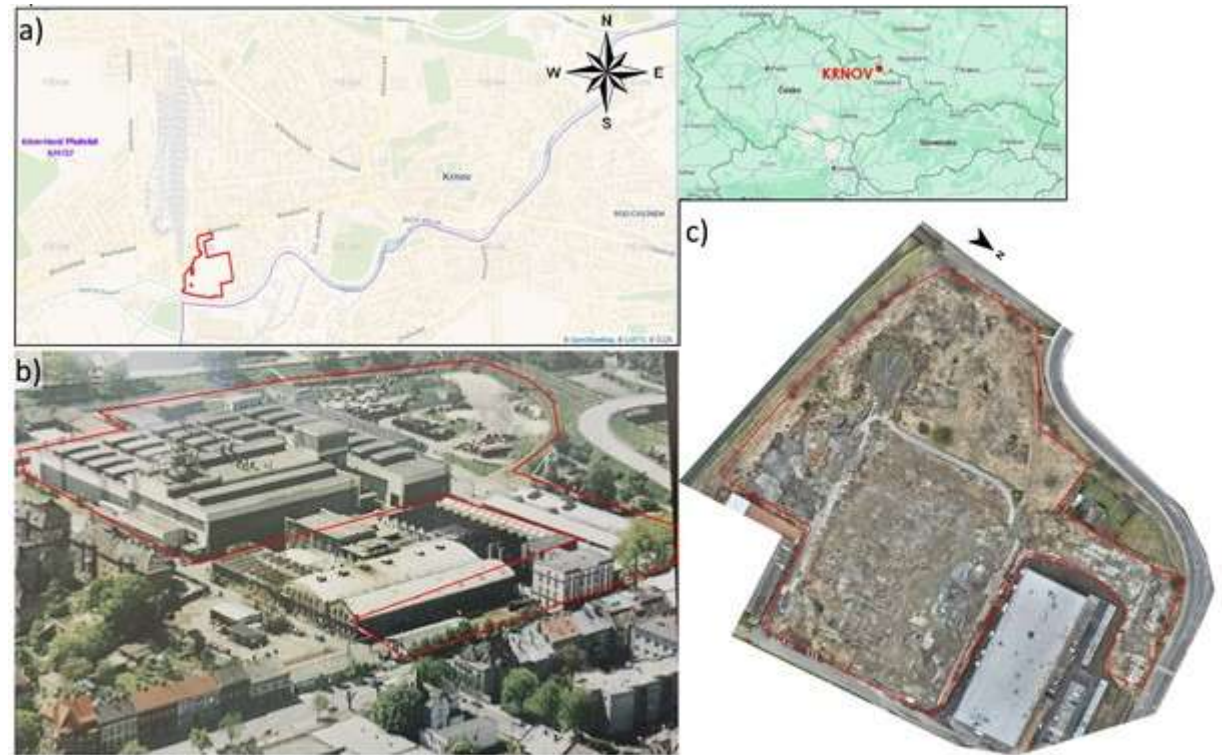
Fig. 1: Study area: a) study area within the town of Krnov (base source ...), b) historical photograph of the former Krnov foundries with the study area indicated, c) study area – condition at the time of the 2024 investigation.

Geophysical survey has become a commonly used tool within engineering geological investigations, whether for assessing landslide areas, designing remediation measures, foundation engineering, and related tasks (Bláha, 2017; Ľahučká et al., 2024; Brixová et al., 2022; Al-Heety et al., 2016; Pasierb et al., 2019). Depending on the objectives and the selected method, geophysics provides useful information about the subsurface. However, the choice of a suitable geophysical method is often constrained by the parameters and the nature of the environment. The surrounding environment posed a particular challenge in the survey presented here. Its goal was to verify the presence of underground structures, spaces, and tanks within the area of the former foundries in Krnov. The area of the former foundries in Krnov (Czech Republic) is situated in the SW part of the town near the railway station (see location figure). In 2013–2014, the obsolete foundry buildings were demolished and, following removal of the structures and disposal of construction waste, a plot with a total area of approximately 4.3 ha was created (Fig. 1), where the survey was to be conducted.

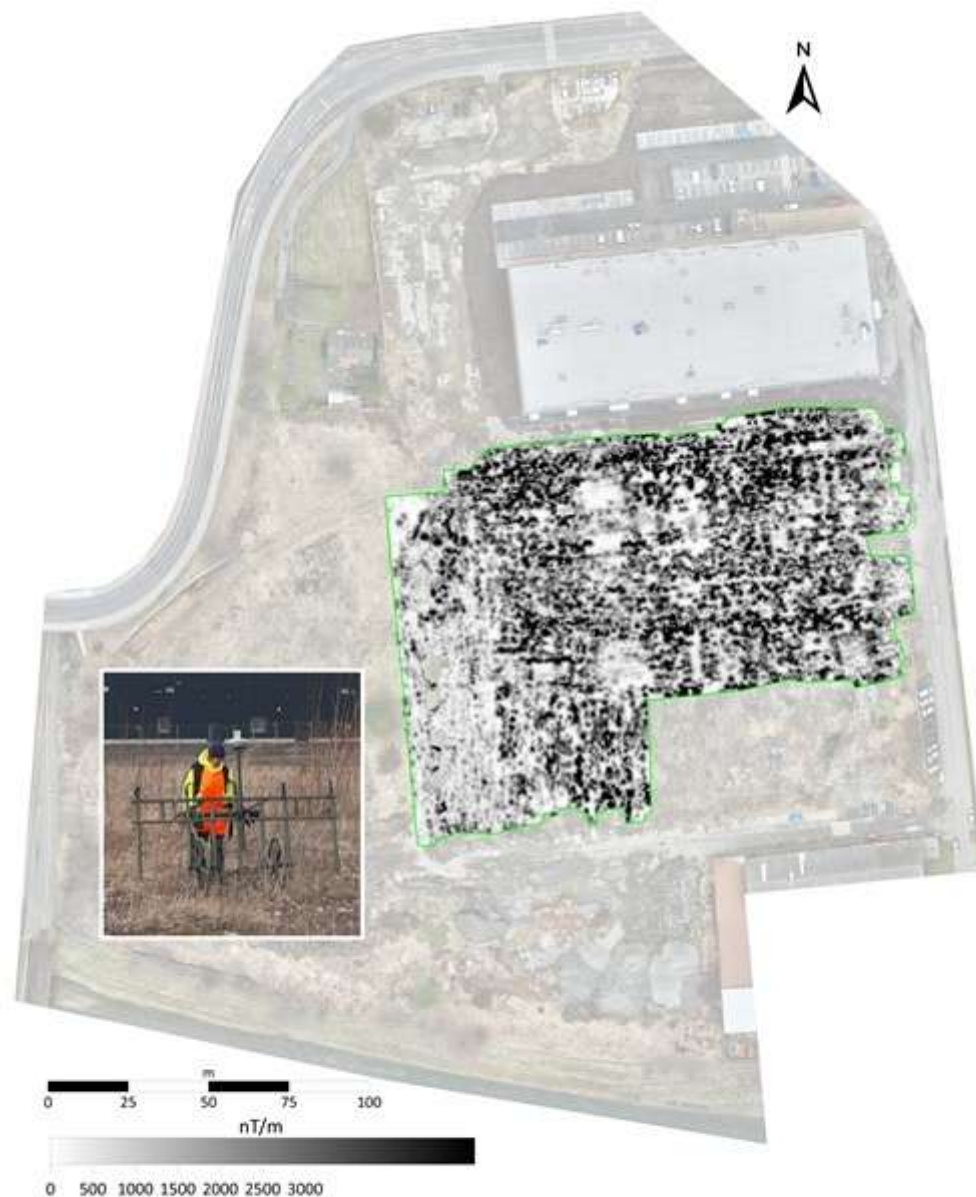
Fig. 3: Map of the analytical magnetometric response across the area of the former foundries with an example measurement using the SENSYS MAGNETO MXPDA device with five fluxgate probes.

In the first stage, processing of the magnetic survey included application of a correction to each series of measurements to remove level offsets between individual sensors. The data were subsequently interpolated to a 0.2×0.2 m grid to produce an areal map of the anomalous magnetic field. However, the presence of large quantities of iron material—most likely originating from the demolished foundry buildings—caused the anomalous magnetic field over the surveyed area to exhibit severe distortions, reaching extreme values of several thousand nanotesla. Consequently, the analytic signal field was computed from the grid (Fig. 3), which suppressed the dipolar character of the field and made the anomalous image more readable. By identifying local maxima of the analytic signal occurring above the centers of detected objects, it was at least partially possible to interpret the outlines of underground objects. These appeared on the interpreted map as linear anomalies in shades of grey to black. In addition, local patches of approximately rectangular shapes appeared that exhibited minima of the analytic signal and were interpreted as relatively homogeneous areas without a high concentration of iron objects. Despite the adjustments and gap-filling of unsurveyed data, the resulting image remained difficult to interpret in more detail.

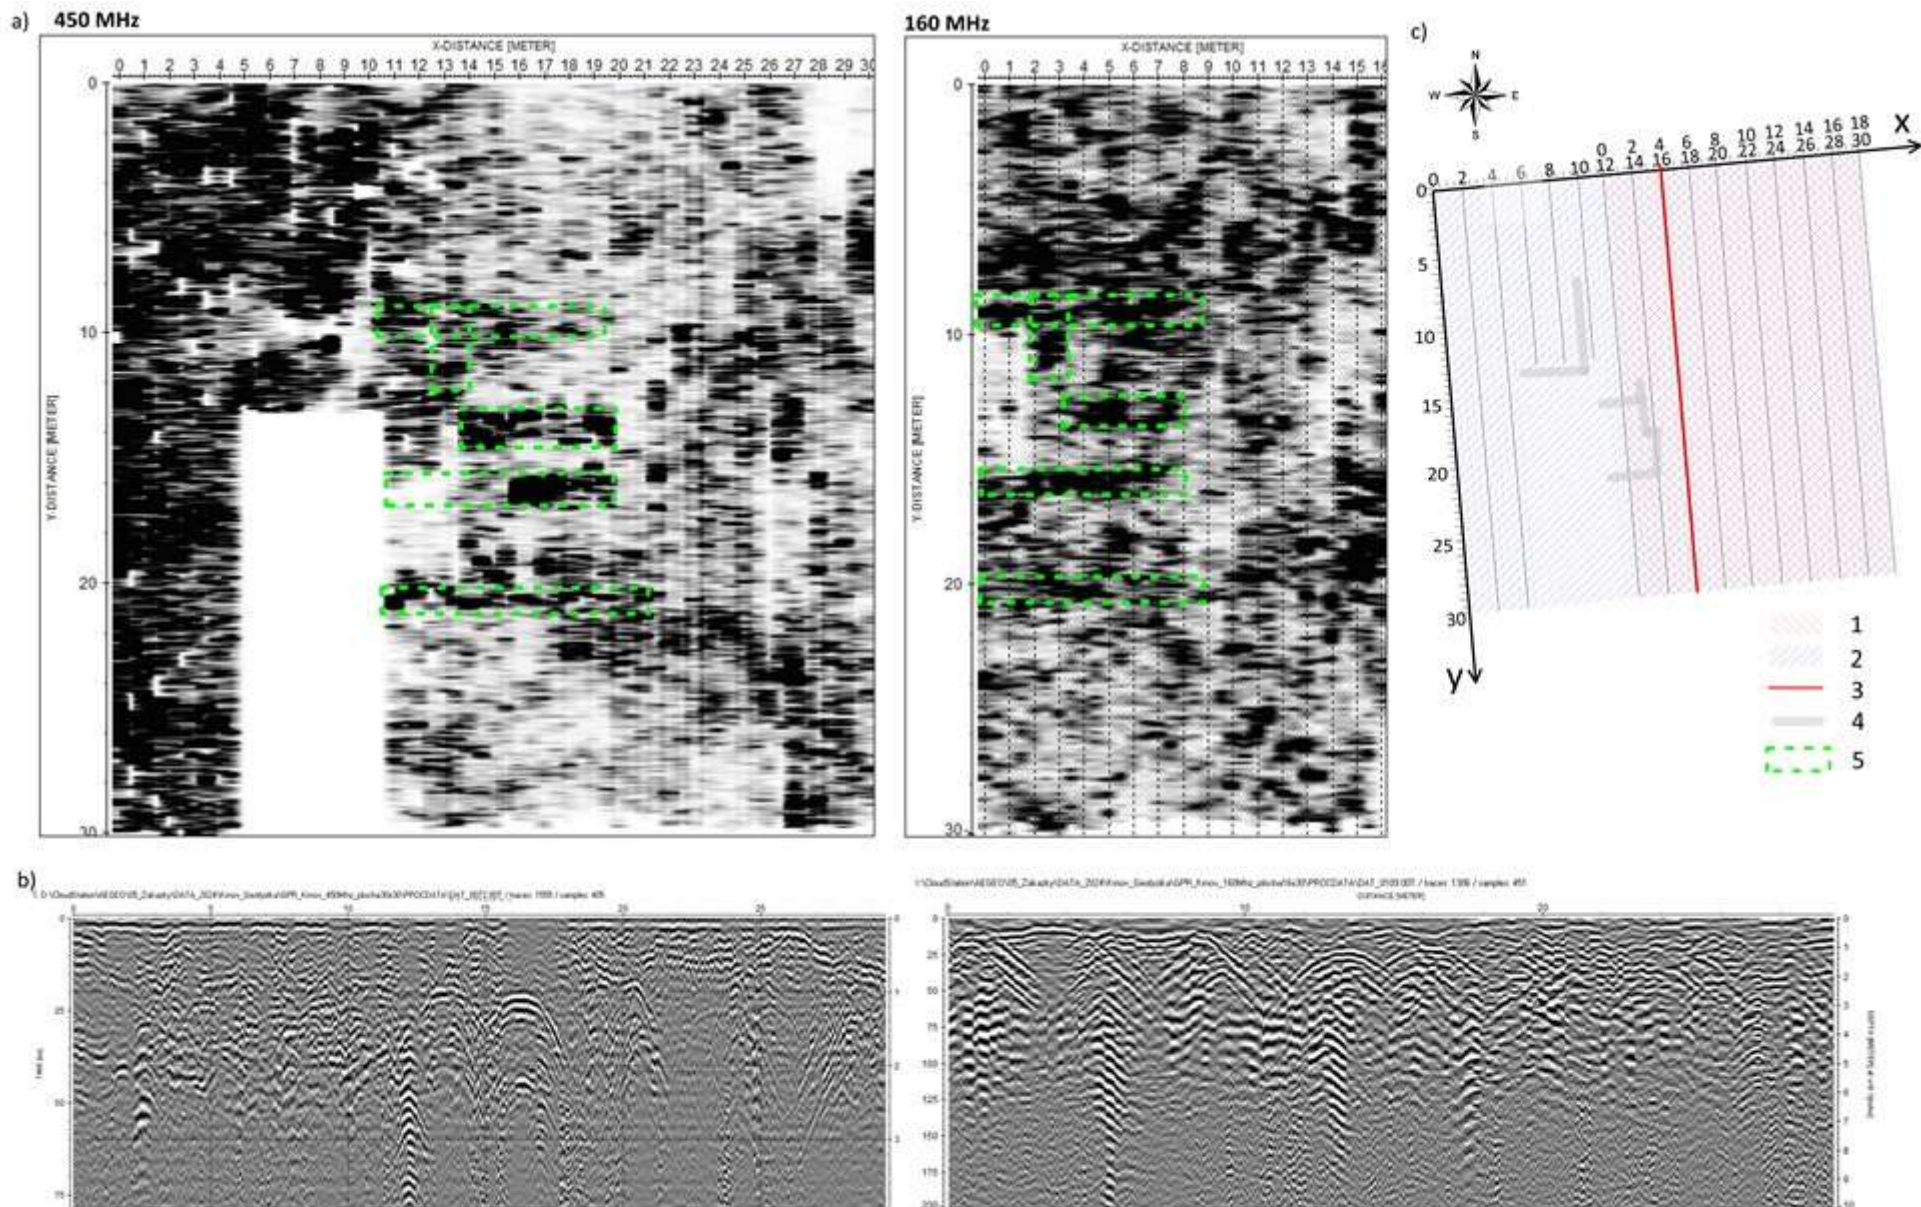
Fig. 6: Results of areal GPR survey with 450 MHz and 160 MHz antennas: a) plan-view radargram at a depth of 1.04 m; b) example of a vertical 2D radargram from a selected profile; c) survey layout. 1) areal survey with 160 MHz antenna, 2) areal survey with 450 MHz antenna, 3) displayed 2D profile, 4) remains of foundations reaching the surface, 5) interpreted anomalies.

phase values were also produced for the 2.2 m and 4.2 m depth levels (Fig. 5). The anomalies highlighted in these areas may correspond to remnants of metallic or reinforced-concrete structures. Interestingly, anomalies labelled 1 and 2 are present on both the apparent resistivity and In-phase maps only for the 2.2 m depth level; their expression disappears at greater depths, which would indicate that their sources are shallowly buried. Anomaly 3 occurs in the area where, according to historical materials, a chemical storage facility had been located. This anomaly was confirmed and refined by the areal GPR survey (Fig. 6). On the areal radargrams (Fig. 6a), despite significant noise, the outlines of remnants of a subsurface building can be seen. On the 2D vertical radargrams (Fig. 6b), the presence of remnants of iron structures is expressed by strong multiple reflections.
