# BLASTING WORKS FOR CLEARING OF STREAM BED KNĚŽMOSTKA BROOK

On the base of request of the Labe Water Authority, state owned enterprise, was executed a prefeasibility study for performance of blasting works for a clearing of clogged stream bed of the Kněžmostka brook in the protected area Natura 2000-Drhleny. The Water Authority took a step to fruitful execution of the blasting works in the brook after approval of the prefeasibility study. The sludge in the stream bed was released and flowed away from a site where produced a problems with flowing. The seismic methods and resistivity tomography proved successful for realization of the project.

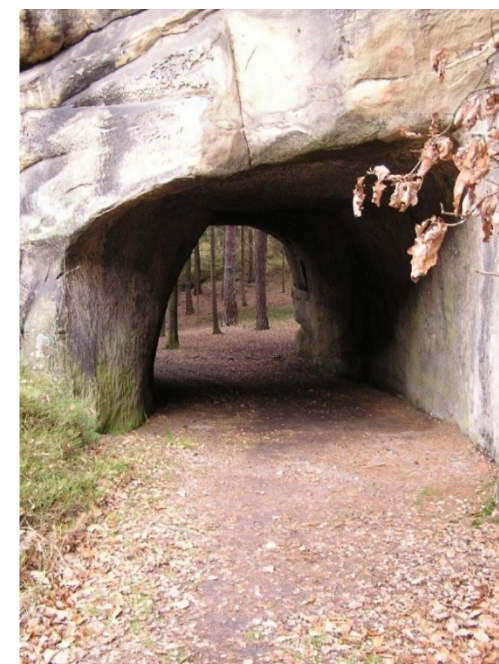
**Fig. 2 Small tunnel in the sandstone makes only transport for a hand – operated cart**

Forest paths are very narrow and bad quality. A transport for excavators and the similar machinery is practically impossible. See Fig. 2. The slope round the brook is steep. See Fig. 3. The stream bed was clogged. See Fig. 4. The difficult field conditions were the case of an idea that for a clearing of clogged stream bed will be used blasting works.

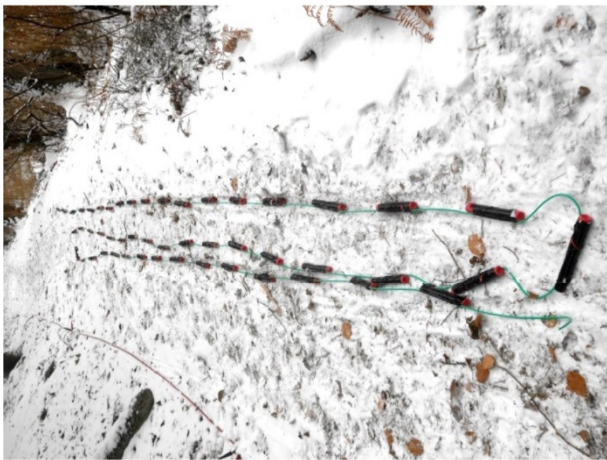
***Fig. 7 The column charge with detonating fuse Startline 12***

The column charge is showed on the Fig. 7. The shooting work is showed on the Fig. 8 a, b and 9. The works were in motion of the winter, when the temperature was round – 2°C and the valley was frozen.

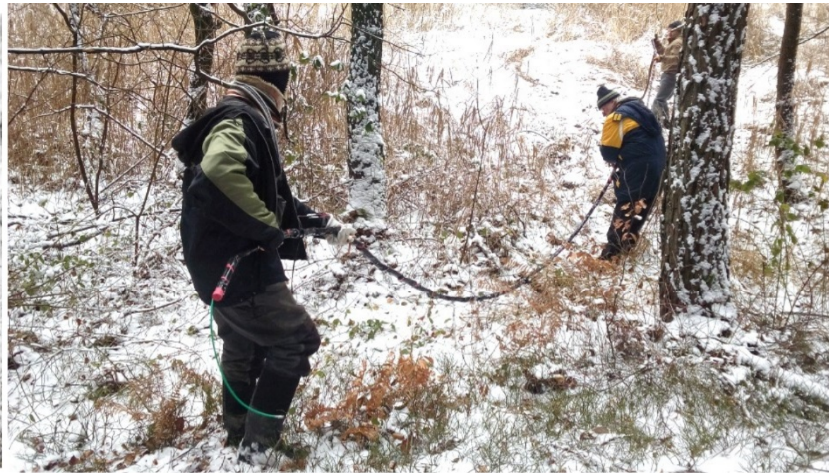
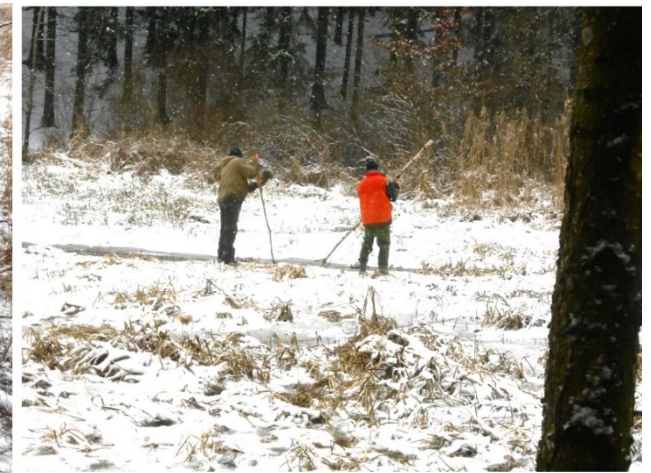
***Fig. 8a, b Shooting works***

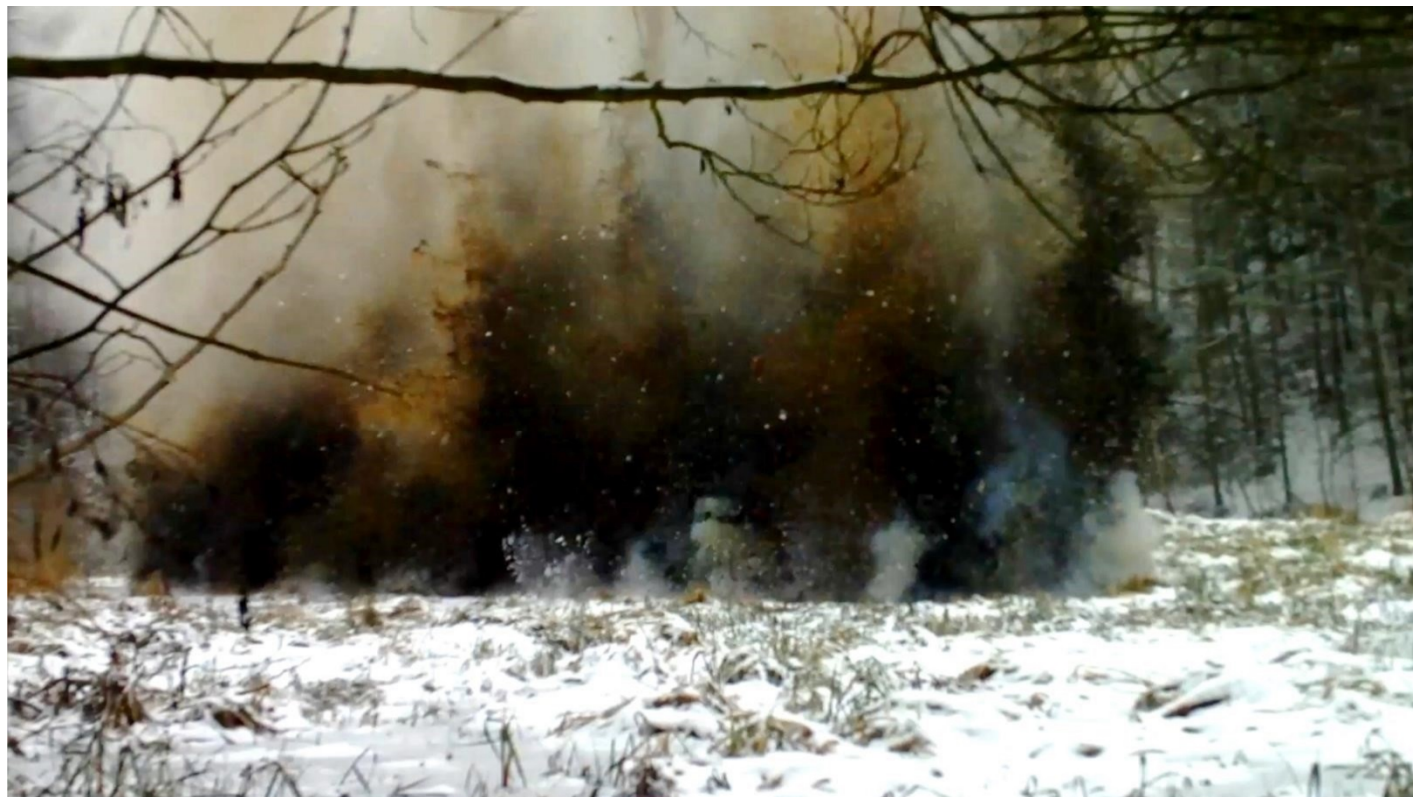
*Fig. 9 Shot*

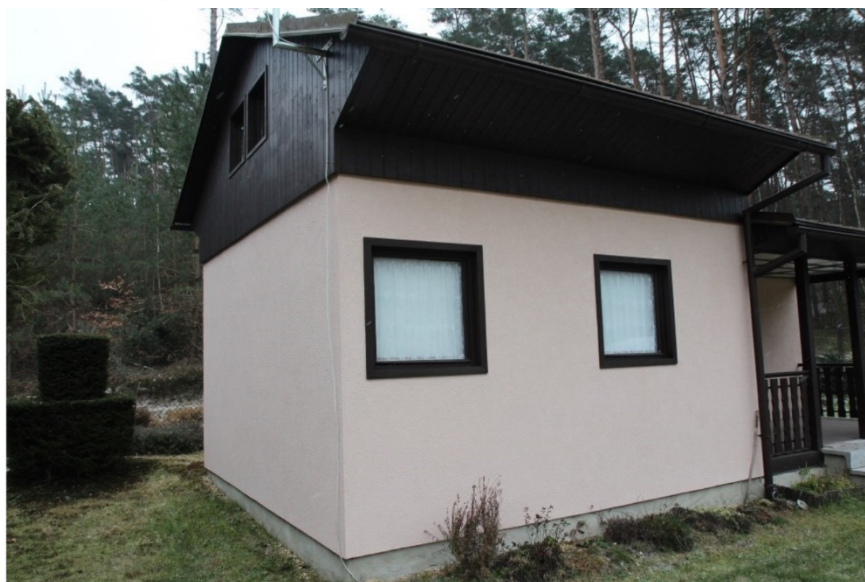
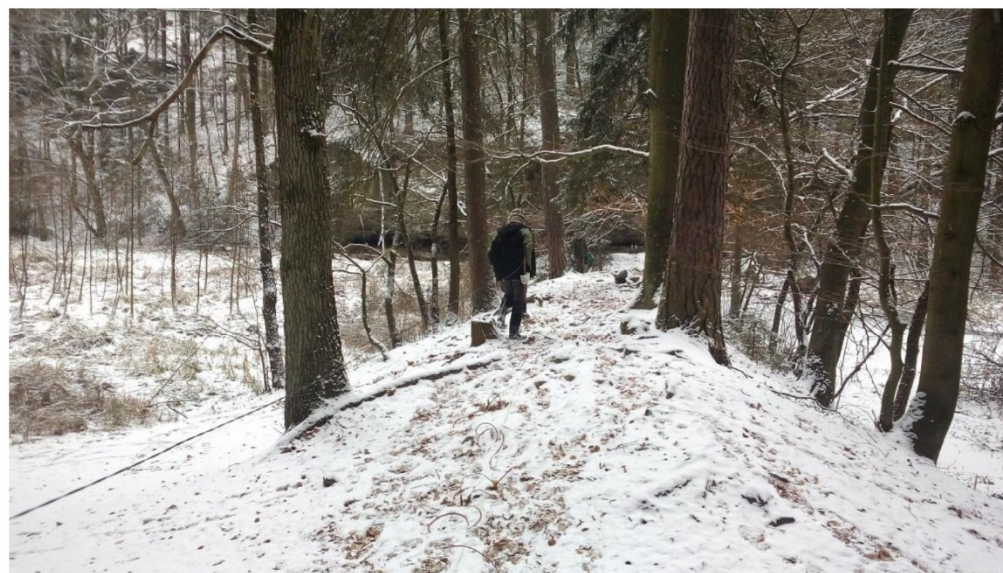
The example of seismic record from seismic equipment GIA and GIB are showed on Fig. 12. The typical objects which could be potentially in danger are imaged on Fig. 13.

**Fig.13** The typical cottage from Nová Ves village (a) and the small dam on the south end of the shutting trace (b)
